FUNGUS AND FEATHERS: COMBATTING A MOLD OUTBREAK IN AN ORNITHOLOGICAL COLLECTION

PEPPER W. TRAIL, ARIEL M. WOODWARD, AND JOHNNIE H. FRENCH

*U.S. Fish and Wildlife Service, National Fish and Wildlife Forensic Laboratory,
1490 East Main Street, Ashland, Oregon 97520 USA
pepper.trail@gmail.com*

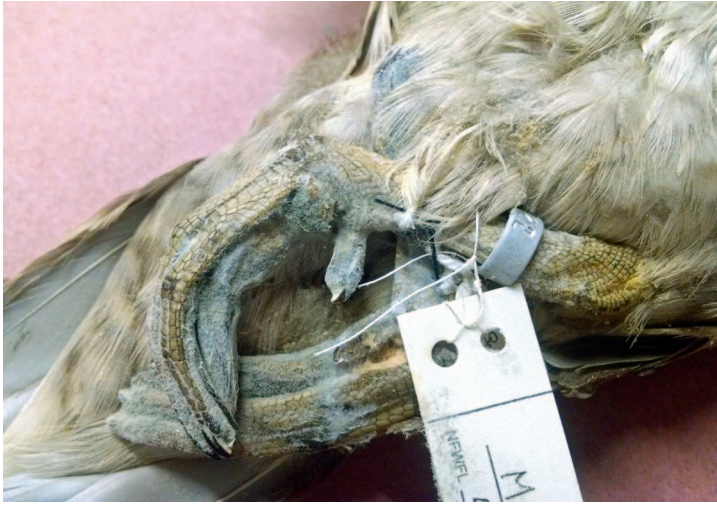
Figure 1. Mold on a duck specimen housed in a cabinet in the offsite warehouse, 2014.

Beginning in 1993, the growth of the collection required that a portion of the specimens be kept in a series of offsite commercial warehouses. There were repeated climate control problems in these facilities. In October 2014 a number of bird specimens in one cabinet at an offsite warehouse were found to be infested with mold. Mold was present on some feathers, but was evident mostly on the legs, feet, and other bare skin (Fig. 1). Detailed inspection also revealed mold on some mammal trophy specimens in the open air of the warehouse. The mold resembled gray bread mold, but was not identified.

The mold growth was cleaned from the specimens by swabbing with VirexTM (ammonium chloride disinfectant). Most of the specimens in the cabinet showed no visible mold. The affected cabinet was emptied, cleaned with Virex, and maintained with desiccant and without specimens for several weeks before being returned to use. Continued monitoring revealed a second outbreak of mold on a few bird specimens in an adjacent cabinet in May 2015. This was less extensive than the earlier infestation, and no mold was found on

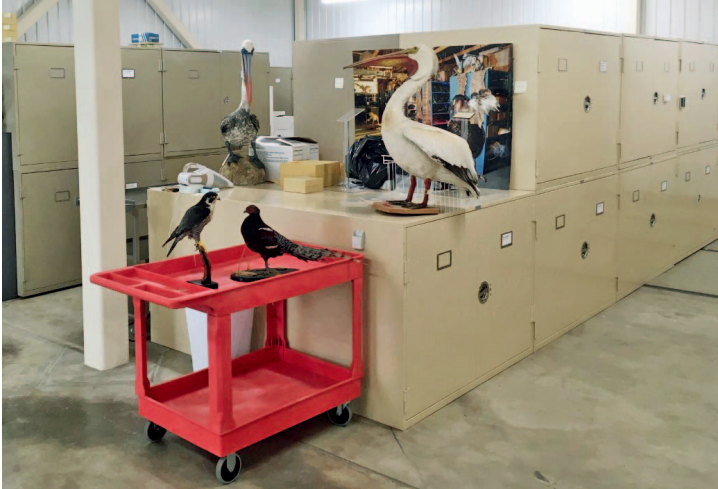
Figure 2. Cabinets with bird specimens shortly after installation in the new collections building, resting directly on the floor, May 2020.

The elevated humidity inside the lower cabinets was likely made worse by the fact that many cabinets did not have their footer hole seals in place, allowing water vapor to enter from below, and by the sealant along the bottom of the cabinets. All these factors created a “perfect storm” of elevated humidity inside the bottom cabinets.

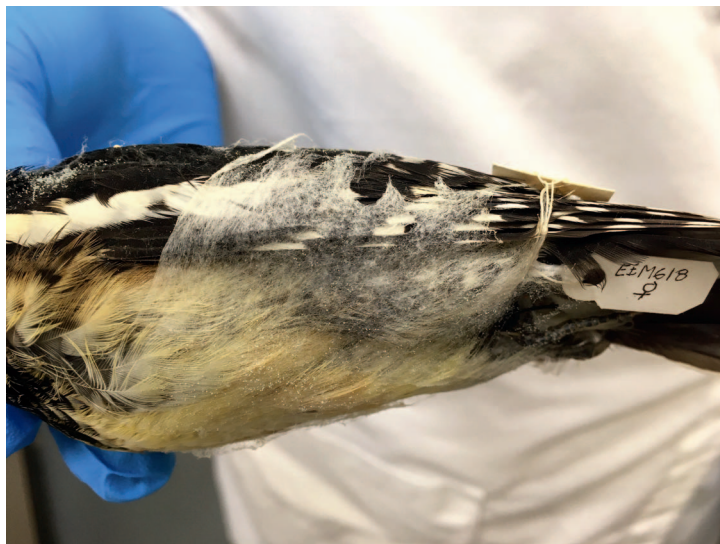
Figure 3. Woodpecker specimen with “shroud” of mold filaments, August 2020.

Late in the day on 5 August 2020, a heavy mold infestation was discovered in one drawer of the cabinet containing the woodpeckers. Some specimens were enveloped in a “shroud” of filmy gray mold (Fig. 3). This growth was far more severe than any seen in the 2015 incident at the warehouse facility. All specimens in the woodpecker cabinet were examined, and those with mold were placed in plastic bags and moved to a -15°F (-26°C) freezer, which stops mold growth, although it does not kill the spores (CCAHA 2019). The two adjacent cabinets were also quickly inspected and no additional mold was found.

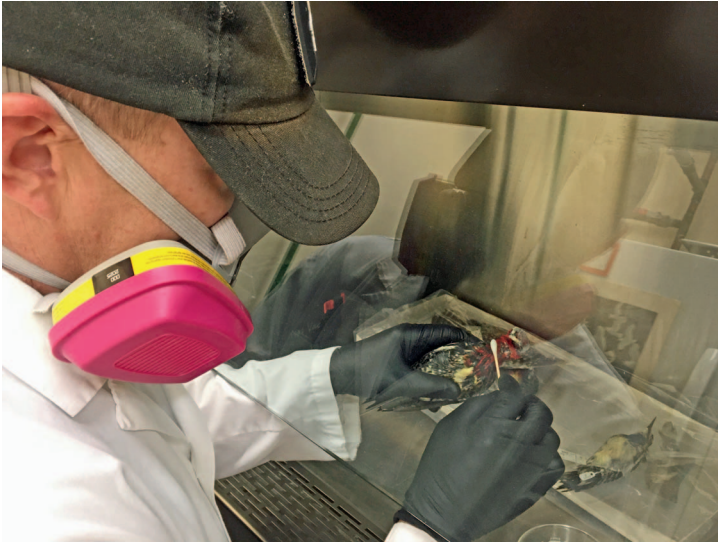
Figure 4. Cleaning a mold-infested red-breasted sapsucker (*Sphyrapicus ruber*) specimen with an ammonia-soaked swab inside a biosafety cabinet, August 2020.

Beginning on 18 August, the mold-affected specimens were removed from the freezer for treatment. Specimens were cleaned in a biosafety cabinet with swabs dipped in a 30% ammonia solution (Fig. 4), followed by vacuuming with a HEPA vacuum after drying. Cleaned specimens were left in the bio-safety cabinet with the UVC bulb turned on for an additional 24 hr of exposure to both dorsal and ventral sides. We recognized that treatment of specimens with ammonia solution and extended exposure to UV light could have damaging effects on the color and even physical structure of the feathers (Pearlstein et al. 2014). However, we felt that drastic measures were required to deal with this severe mold infestation, and that the relatively small number of specimens involved justified the risk. None of these specimens have exhibited discoloration in the year since they were subjected to these treatments. However, there have been physical affects, with some treated feathers appearing matted and stiff. To avoid the possibility of damage, we followed different cleaning procedures in subsequent treatments, as described below.

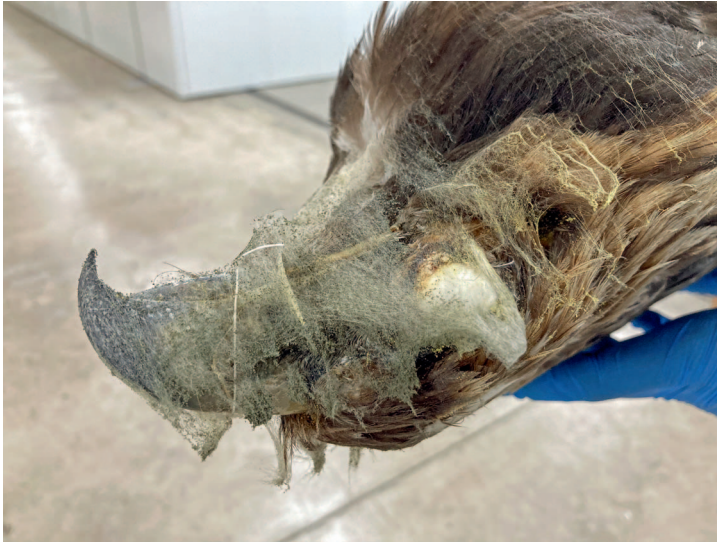
Figure 5. Golden eagle (*Aquila chrysaetos*) specimen with “shroud” of mold filaments, September 2020.

On 10 September, heavy mold infestation was discovered in a new cabinet, containing Caprimulgiformes (nightjars and allies) and Apodiformes (swifts and hummingbirds). Again, some specimens were enveloped in a shroud of filmy mold. The extreme seriousness of the mold outbreak was now apparent. On 11 September (a Friday), R-CARD™ mold test strips were placed inside the cabinets. Virtually all these test strips showed mold growth by the following Monday, even those inside cabinets with no visible mold on the bird specimens. Complete inspection of all bird cabinets was delayed by a wildfire emergency in the region, but was completed on 15 September. Mold was found on a minimum of 70 bird specimens in a total of 12 cabinets, including some that had been in regular use, such as the cabinet with Golden Eagles (Fig. 5). This mold growth had occurred in just the few weeks since the reinstallation of the specimens in late August. All but one of the affected cabinets were in the bottom rows, resting on the floor and with sealant along their bases. As before, all specimens with visible mold were bagged and removed to the walk-in freezer.

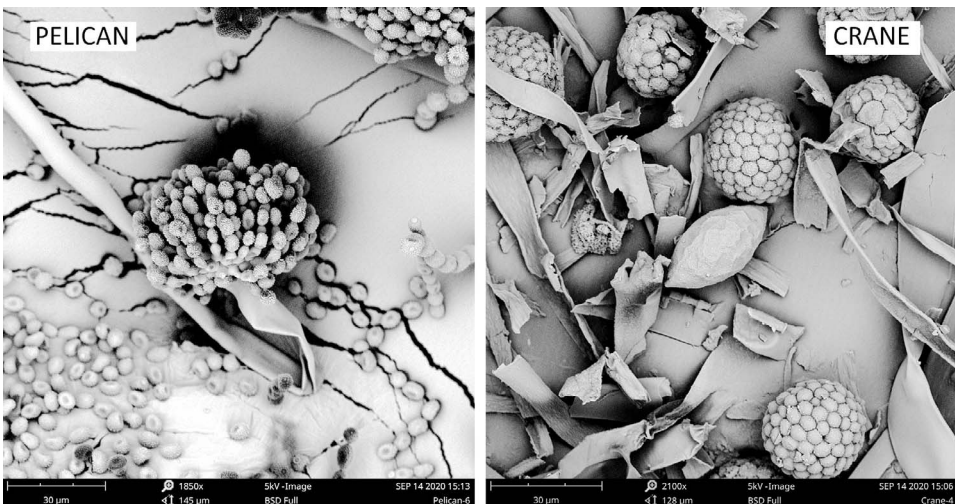
Samples were also sent to SGS Forensic Laboratories for genetic analysis. By late September, the conclusion was that at least three types of mold were present: *Penicillium brevicompactum* Dierckx, *Eurotium* (the sexual state of *Aspergillus*), and *Paecilomyces variotii* Bainier. Although hazard levels associated with different molds are not well characterized, these are not among the mold types considered most dangerous to human health (Campbell et al. 2004). As a precaution, the PPE requirements were left in place until 6 November,

Figure 7. Scanning electron microscope (SEM) images of mold spores sampled from pelican and crane specimens, September 2020. Magnification 1,850 \times for pelican sample and 2,100 \times for crane sample.

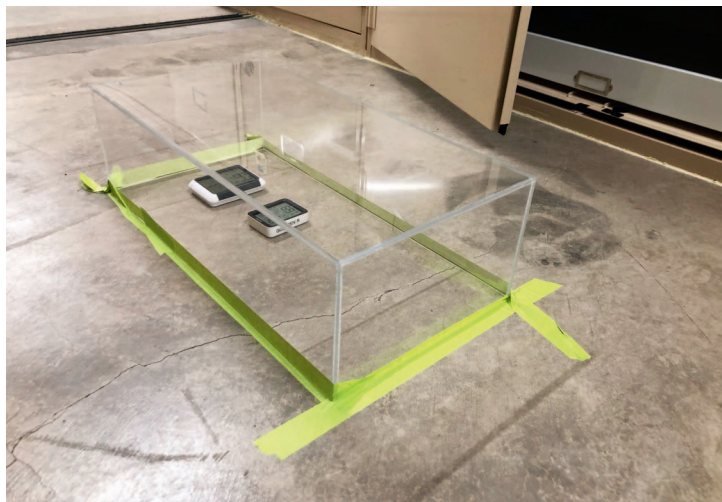
Figure 8. Improvised sealed enclosure to measure humidity emanating from the concrete floor of the collections building, September 2020. Note the strip of silicone seal along the base of the cabinets.

On 29 September, Govee humidity sensors were placed on open areas of the floor and sealed inside clear plexiglass enclosures on both levels of the Morphology Center (Fig. 8). On the first floor, the sensors almost immediately registered increases in RH when these improvised enclosures were sealed, eventually rising from the ambient ~45% to 70% or more (max. 83%; Fig. 9). Changes in humidity readings were timed following the removal of one of the sealed tubs, and the RH dropped from 70% to 56% in 11 sec. Sensors in sealed tubs on the concrete floor of the second level did rise, but to a lesser extent, from 43% to 55% RH.

These tests confirmed that evaporation from the concrete floor appeared to be the source of the excess moisture raising humidity inside the cabinets. Concrete experts consider that concrete takes about 30 days to dry for every 1 in. of slab thickness. The process of concrete

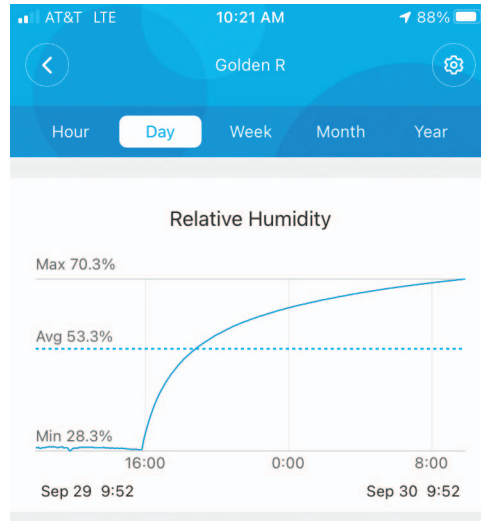
Figure 9. Data log from Govee™ humidity sensor showing dramatic and immediate rise in humidity following sealing of the enclosure at 4:00 PM, September 2020.

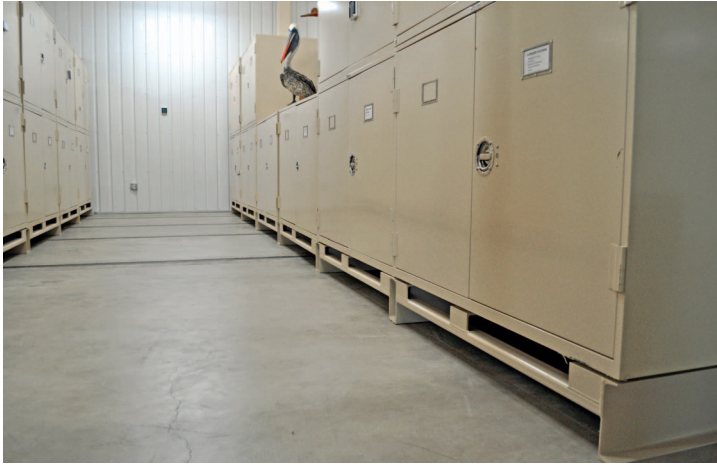
Figure 10. Cabinets with bird specimens raised 8 in. off the floor on custom-fabricated metal risers, February 2021.

The decision was made in early October 2020 to raise all 48 lower bird cabinets 8 in. off the floor on custom-fabricated metal risers. Less-costly wooden risers were rejected because wood might absorb moisture and could also need eventual replacement. Design and fabrication were accomplished by a local firm, Medford Fabrication. The process of obtaining funding and fabricating the risers took 4 mo. In the meantime, the museum cabinets were all temporarily raised on wood two-by-fours, and the doors were left cracked open to allow some air flow. The mold-infested specimens remained in the freezer awaiting placement of the cabinets on the permanent metal risers.

The metal risers were delivered in early February 2021, and completely installed by mid-February (Fig. 10). Once the repositioning was complete, every bird cabinet in both upper and lower rows was thoroughly disinfected. The bird specimens without visible mold had been stored in these cabinets throughout, as there were no other storage options available. All specimens were temporarily removed and every drawer as well as the interior walls and doors of each cabinet was wiped down with 80% ethanol. After the ethanol was evaporated, the specimens were placed back in the cabinets, which were returned to their normal sealed condition. Internal humidity levels inside the closed cabinets were monitored and verified to remain at the building's ambient levels of 45–50% RH.

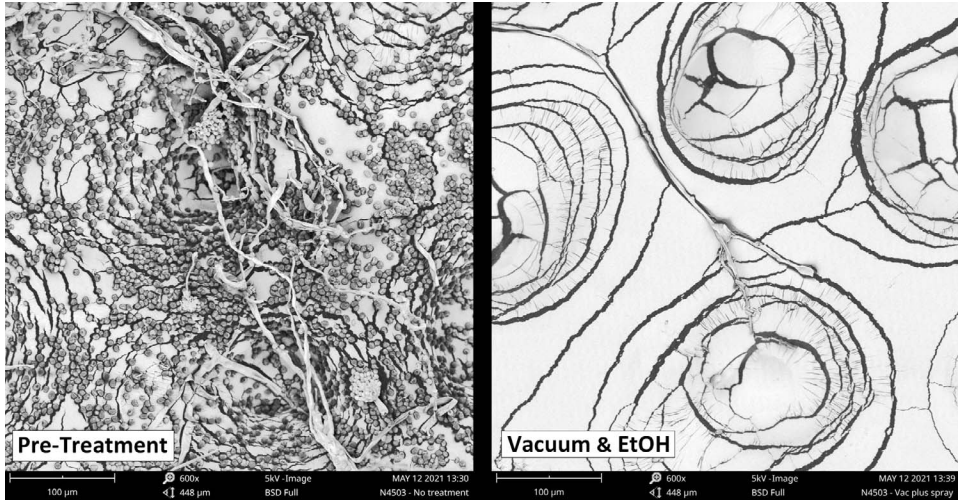
Figure 11. SEM images of the plumage of brown eared-pheasant (*Crossoptilon manchuricum*) specimen N4503 before mold removal (left) and after treatment with the HEPA vacuum and ethanol spray (right). Both images at 600 \times magnification. Only a few damaged fungal hyphae (one shown) and spores remained following treatment. The concentric cracks in the images are artifacts in the surface of the SEM stub.

Removal of mold was carried out in a bio-safety cabinet with the use of a powerful Atrix Express VacTM handheld vacuum with a HEPA filter. Nylon screening with a

2 × 2 mm (0.08 × 0.08 in.) mesh was attached around the nozzle to prevent feathers from being pulled into the vacuum. This vacuuming removed all visible mold growth.

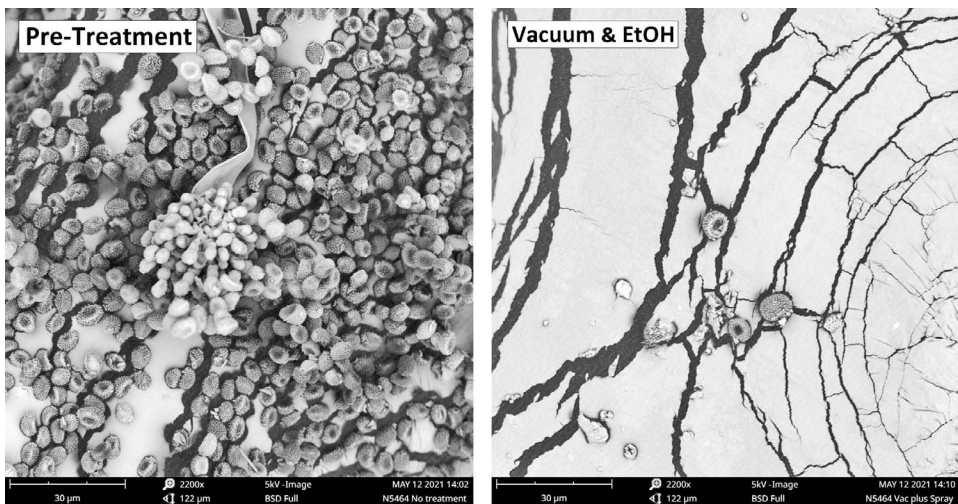
Figure 12. SEM images of the plumage of crestless fireback (*Lophura erythrophthalma*) specimen N5464 before mold removal (left) and after treatment with the HEPA vacuum and ethanol spray (right). Both images at 2,200 \times magnification. Only a few damaged fungal spores (shown) and hyphae remained following treatment. The concentric cracks in the images are artifacts in the surface of the SEM stub.

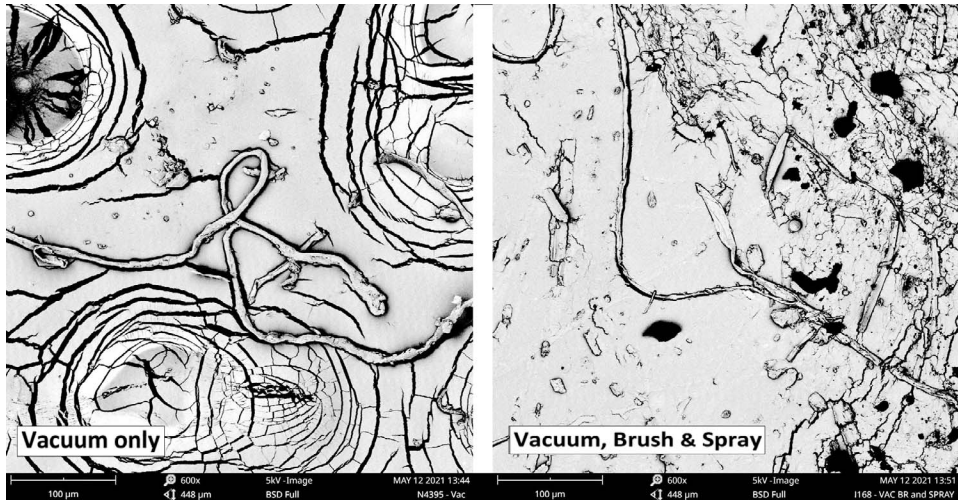
Figure 13. SEM images comparing treatment with HEPA vacuuming only (left) and vacuuming plus ethanol treatment with a fine brush followed by light ethanol spray (right). Golden eagle (*Aquila chrysaetos*) specimens N4395 (left) and N168 (right). Both at 600 \times magnification. Vacuuming alone was highly effective at removing spores, with only some damaged hyphae remaining (shown). Vacuuming followed by ethanol treatment appeared to lead to further lysing of fungal hyphae and produced unidentifiable debris (shown).

For heavily mold-infested specimens, vacuuming was followed by treatment with 30% ethanol. This concentration was found to be effective by testing of the treated specimens, as described below. Ethanol application varied depending on the severity of the infestation and its location. Mold was often located primarily on bare skin of the face and legs. For those specimens, ethanol was brushed over the affected areas. Wedge-shaped makeup removal sponges were used initially, but were found to be less effective than soft makeup brushes. Light brushing with ethanol was also carried out on infested areas of plumage. Finally, for the most heavily infested specimens, a fine mist of ethanol was sprayed above the specimens and allowed to settle into the plumage. Spraying was the technique used for the affected owl specimens, as direct brushing of ethanol was found to mat their loose, soft feathers.
