FUNGUS AND FEATHERS: COMBATTING A MOLD OUTBREAK IN AN ORNITHOLOGICAL COLLECTION

PEPPER W. TRAIL, ARIEL M. WOODWARD, AND JOHNNIE H. FRENCH

*U.S. Fish and Wildlife Service, National Fish and Wildlife Forensic Laboratory,
1490 East Main Street, Ashland, Oregon 97520 USA
pepper.trail@gmail.com*

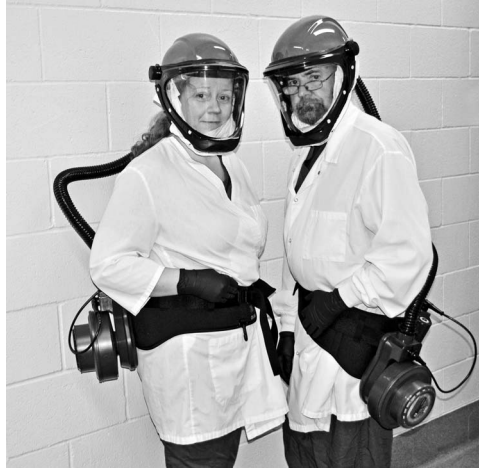
Figure 6. Woodward and Trail in powered air purifying respirator (PAPR) personal protective equipment, September 2020.

The mold outbreak occurred during the COVID-19 pandemic, and so staff wore cloth masks in all laboratory spaces throughout this period. Only limited staff were allowed to enter the Morphology Center, and only when wearing full respirator masks or powered air purifying respirator (PAPR) systems (Fig. 6). The PPE precautions followed those recommended in Guild and MacDonald (2020). When considering the response to the mold infestation, treatment of the Morphology Center with fungicides was rejected, because of the toxicity of these chemicals and their unknown effects on biological materials (CCAHA 2019).
